Manhole Inspection Summary

Manhole # S45EE_038MH

Insp Date: **12/20/07 12:45 PM**

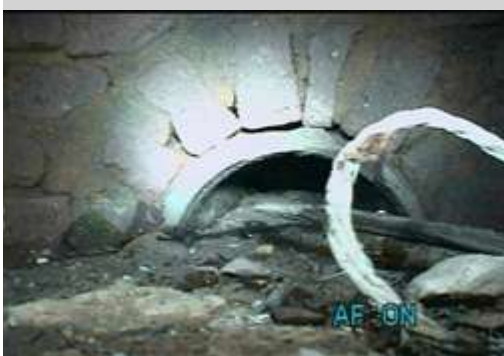
DEFECT 1

Condition: ☐ Sound ☒ **Cracked** ☐ Root Intrusion ☐ Loose Brick ☐ Deteriorated

Condition: ☐ Sound ☐ Cracked ☐ Root Intrusion ☐ Deteriorated ☐ Leaks ☒ **Debris**

channel debris, barrel cracked

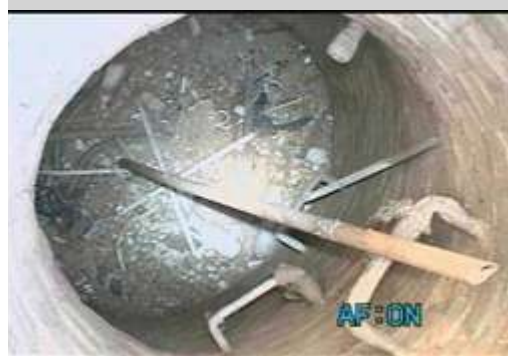
DEFECT 2

Steps Count: **4** Missing: **0** ☒ **Corroded**

steps corroded

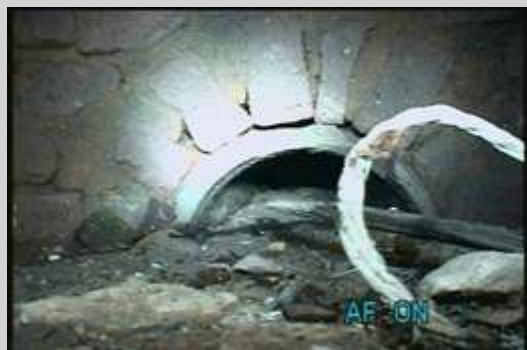
12 O'Clock Outflow

Deposits: ☐ None ☒ **Mud** ☐ Sludge ☒ **Debris** ☐ Grease

Silt Depth: **4** (in.) Deposits Extent: **Heavy**
